# BELZONA PROTECTED SUBMERSIBLE SLUDGE PUMP SIX YEARS ON

ID: 6125

Customer Location: *Paper Mill, Italy*  
Application Date: *June 2016*

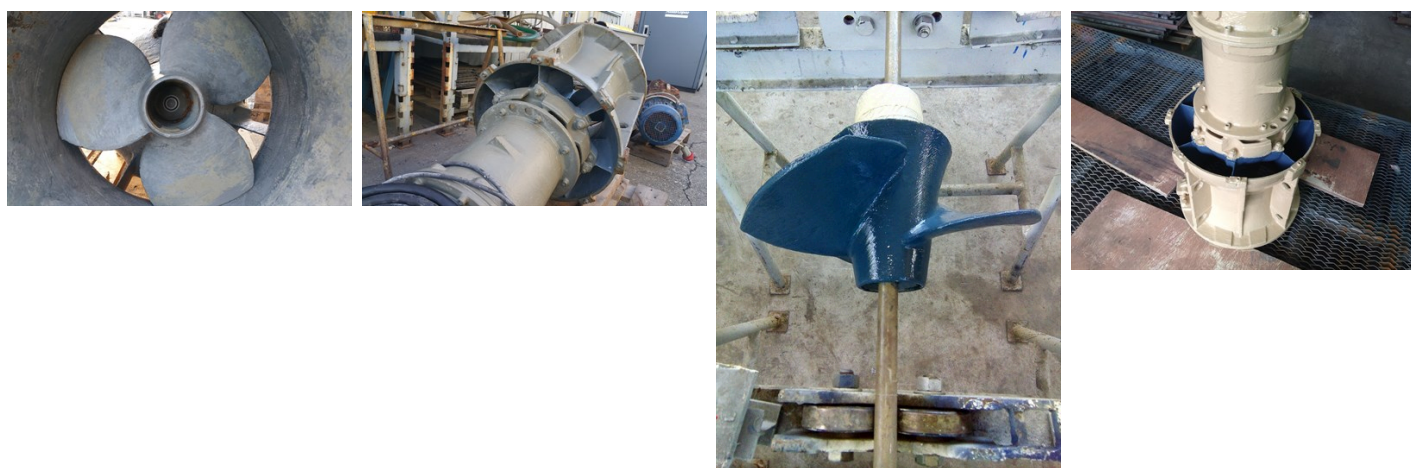
*Previously the pump only lasted two years in service before requiring major overhaul. Originally coated in 2010 with Belzona, after six years of uninterrupted service, the customer opened the pump for mechanical maintenance. Belzona coating was found to be in excellent condition but it was decided to refresh the Belzona protection to prepare the pump for more years of service in sludge.*

- \* Internals after six years in service ,
- \* Casing after six years in service ,
- \* Impeller recoated in 2016 ,
- \* Casing and internals recoated in 2016 ,

The application was carried out in accordance with Belzona Know-How System Leaflets CEP-1, CEP-3 and CEP-4. The coating applied

in 2010 was roughened and the new coating was applied on top.
