BELZONA CASTING IMPERFECTION REPAIR

ID: 613

Industry: *Fluid Flow*
Application: *CEP-Centrifugal Pumps*
Substrate: *Cast iron*
Products: ** Belzona® 1311 (Ceramic R-Metal) ,*
** Belzona® 1321 (Ceramic S-Metal) ,*

Cast pump casing

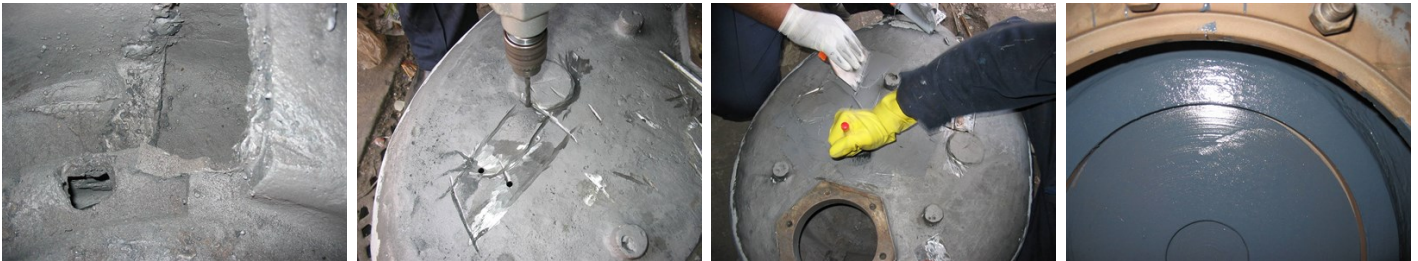
Photograph Descriptions

Defects in casting caused holes and cracks in the pump.

- * Casting imperfections in the pump ,
- * Preparing the cracks in the pump ,
- * Wetting out the surface with Belzona® 1311 ,
- * Pump was repaired and protected ,

Application was carried out in accordance with Belzona Know-How System Leaflet CEP-3 and CEP-6.

Instead of recasting the pump which would take too long and be very expensive, Belzona easily repaired the casting imperfections and also provided protection to the pump.
