BELZONA BULKFILL RESTORES STEPS AT A HOSPITAL

Application: FPA-Floor Problem Areas

Application Date: April 2013

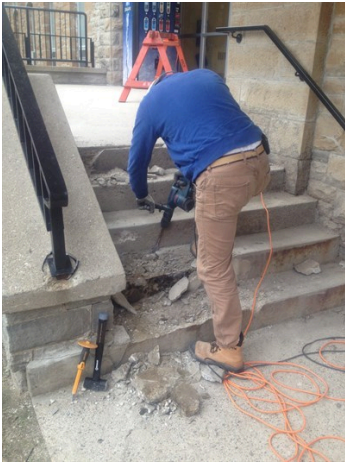
The steps had suffered severe damage and spalling caused by weathering, salt and freeze thaw effect. Large cracks and spalled stone were visible making the usage of the steps dangerous.

- * Preparing the stone back to firm substrate ,
- * Belzona 4154 being packed into former ,
- * Application of Belzona 4131 ,
- * Finished application with Belzona 5231 and 4411 ,

The damaged stone was removed back to a firm substrate. Due to the extent of the damage forms were created and Belzona 4154 was mixed with locally sourced aggregate and packed into place. Once cured the forms were removed and 1/4" of Belzona 4131 was applied over the stair treads and risers. To protect from further weathering and salt Belzona 5231 was applied over the steps with a high visibility yellow Belzona 4411 stripe at the edge of the step tread.
