# BELZONA REBUILDS AND PROTECTS VANES

Industry: *Fluid Flow*  
Application: *CEP-Centrifugal Pumps*  
Substrate: *Cast iron*  
Products: *\* Belzona® 1311 (Ceramic R-Metal) ,*  
*\* Belzona® 1321 (Ceramic S-Metal) ,*

Customer Location: *Water plant, Egypt*  
Application Date: *February 2003*

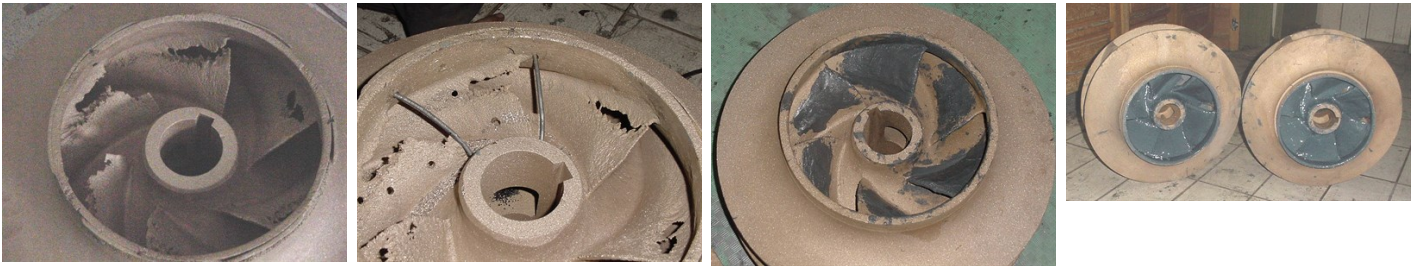
*Vanes of the impellers were severely cavitated.*

- \* The cavitated vanes of the impeller ,
- \* Preparing to rebuild the lost edges ,
- \* Rebuilding the vanes ,
- \* Vanes rebuilt and coated ,

Belzona rebuilt the cavitated vanes saving replacement cost of the impellers. It also provided resistance to cavitation by coating the vanes with Belzona® 1321. This application was repeated with other impellers later and the impellers are still in service.
