# BELZONA BULKFILL REBUILDS HOSPITAL TRASH PAD

ID: 6140

**Industry:** Buildings & Structures  
**Application:** FPA-Floor Problem Areas  
**Substrate:** Concrete  
**Products:** \* Belzona 1121 (Super XL Metal) ,  
\* Belzona 4154 (Bulkfill Resin) ,  
\* Belzona 4131 (Magma-Screed) ,  
\* Belzona 4911 (Magma TX Conditioner) ,

**Customer Location:** Roanoke, VA, USA  
**Application Date:** October 2015

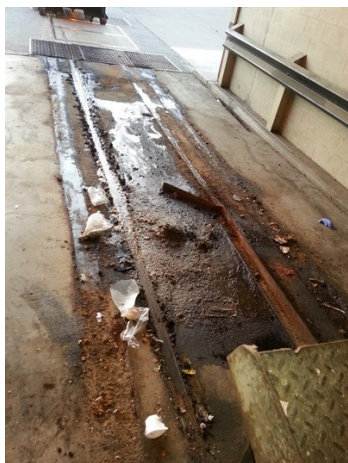
Concrete in roll-off area was deteriorating due to weight and dragging of trash containers. Large hole was a below ground conduit vault. Rain water was entering the vault area and causing electrical hazards.

- \* 1. Damaged concrete of the trash pad ,
- \* 2. Removing and scarification of the damaged concrete ,
- \* 3. Application of Belzona 4154 and 4131 as a top coat ,
- \* 4. Complete application ,
