# BELZONA SOLVES MISALIGNMENT ON QUARRY TRUCK SCALES

ID: 6147

**Customer Location:** Quarry, Croatia  
**Application Date:** May 2016

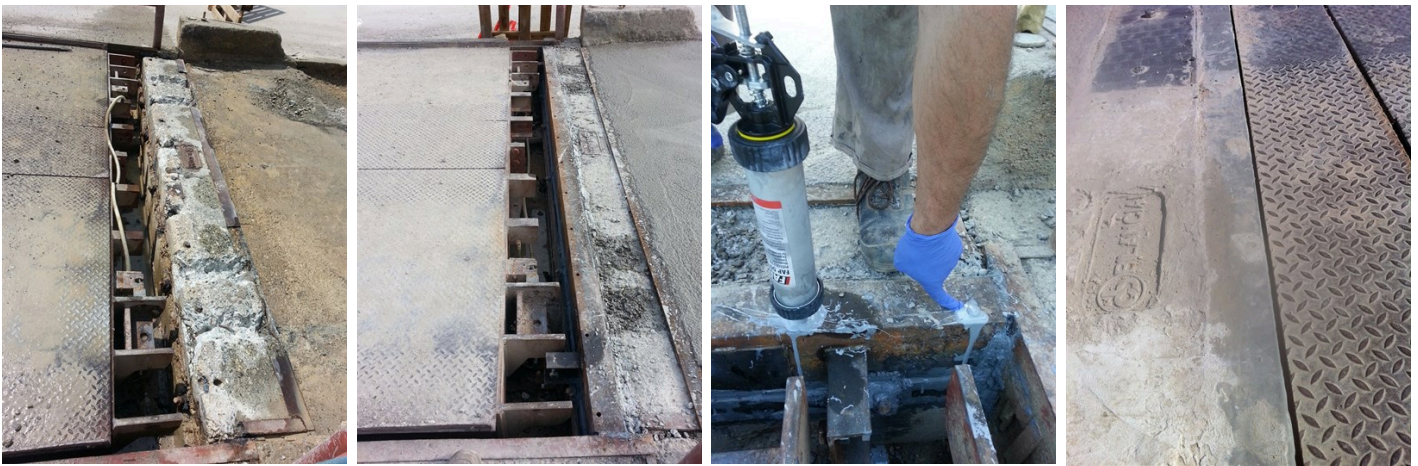
Concrete surface under the metal plate on the approach to the truck scale was badly damaged due to misalignment of mating faces. Truck scale must be in operation during the two shifts per day, six days per week operation of the quarry so fast repair procedure required.

\* 1. Damaged concrete under the old metal plate 2. New metal plate in position with sealed edges. 3. Injection of Belzona 5811 4. Application completed ,

The application was carried out in accordance with Belzona Know-How System Leaflet GSS-9. After installation of the new metal plate, the edges of the mating faces were sealed with Belzona 1111 to prevent leaking of Belzona 5811 which was injected through previously drilled holes.
