BELZONA PROTECTS VIBRATORY SCREENING MACHINE

ID: 6149

Application: SHM-Solids Handling Machinery

Customer Location: Building materials factory, Croatia

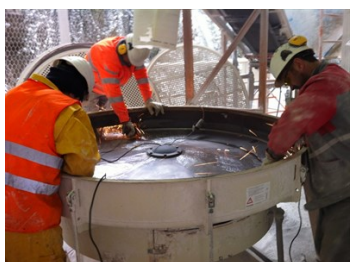
The bottom of the vibratory screen suffered damage from abrasion. Customer needed a fast repair in order to keep downtime to a minimum.

* 1. Surface preparation in progress 2. Surface prepared 3. Application completed ,

The application was carried out in accordance with Belzona Know-How System Leaflet SHM-13.

The same problem occurred on another vibratory screening machine in 2012. Belzona solved it and the machine is still in good condition. The application was carried out during weekend, which enabled start of production on Monday. Because of cold weather, in order to reduce cure time, extra heat was provided with electrical heaters. All alternatives were time consuming and unacceptable to the customer.
