# BELZONA PROTECTS VIBRATORY SCREENING MACHINE

Industry: General Industry  
Application: SHM-Solids Handling Machinery

Customer Location: Building materials factory, Croatia  
Application Date: February 2016

Substrate: Steel  
Products: \* Belzona 1812 (Ceramic Carbide FP) ,

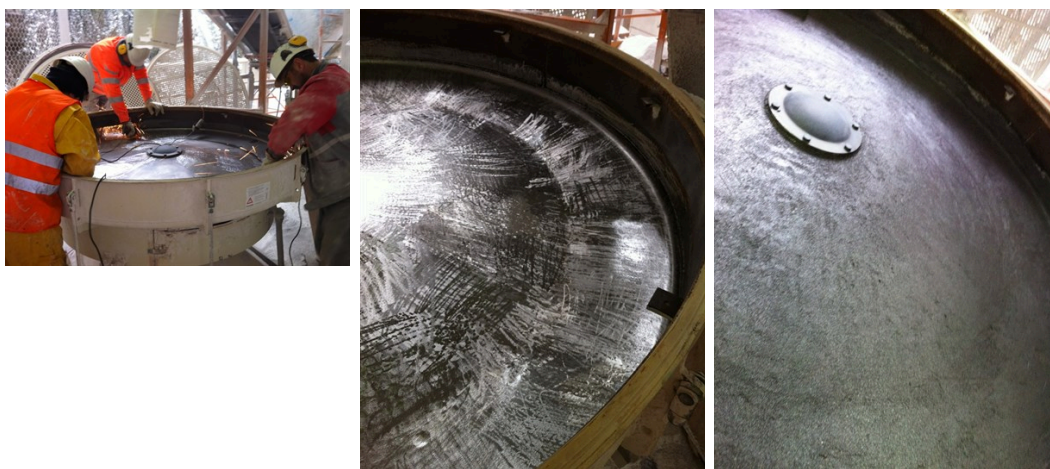
The bottom of the vibratory screen suffered damage from abrasion. Customer needed a fast repair in order to keep downtime to a minimum.

\* 1. Surface preparation in progress 2. Surface prepared 3. Application completed ,

The application was carried out in accordance with Belzona Know-How System Leaflet SHM-13.

The same problem occurred on another vibratory screening machine in 2012. Belzona solved it and the machine is still in good condition. The application was carried out during weekend, which enabled start of production on Monday. Because of cold weather, in order to reduce cure time, extra heat was provided with electrical heaters. All alternatives were time consuming and unacceptable to the customer.
