WATER STORAGE TANK UPGRADED WITH BELZONA COATING

ID: 6157

Customer Location: Oil production platform, UK North Sea
Application Date: June 2016

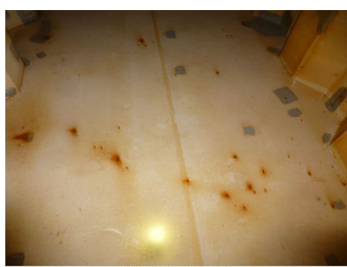
Tank was suffering localised pitting and coating breakdown on deck plates and beam edges. Superior erosion resistant coating required to protect the vessel from further corrosion.

* 1. Deck of tank showing areas affected by corrosion 2. Example of pitting on tank wall 3. Areas of corrosion and pitting repaired with Belzona 1111 4. View of completed application on water tank ,

Application was carried out in accordance with Belzona system Leaflet TCC-5. After preparing substrate by grit blasting, Belzona 1111 was used to rebuild the areas of pitting and corrosion, and then coated with Belzona 1321 to provide erosion-corrosion protection in the lower section of the tank. .
