BELZONA SEALS NEW PIPES IN HOTEL WATER RESERVOIR

ID: 6168

Customer Location: *Hotel, Israel*
Application Date: *2013*

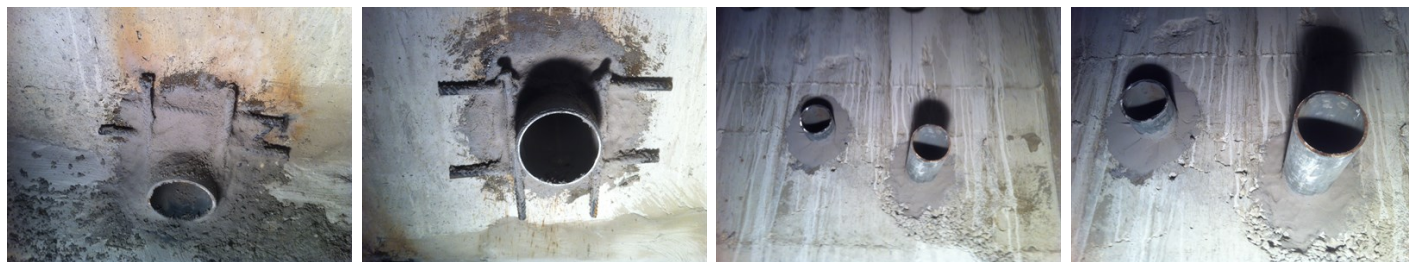
Photograph Descriptions

New pipes drilled into water reservoir needed to be anchored and sealed to the tank wall.

- * 1 & 2. Internal application to secure new pipes ,
- * 3 & 4 External fixing of pipes ,

The costumer was looking for reliable solution since on previous experience leaks had occurred around the pipes. Belzona 4111 provides high bond strength without shrinking enabling a secure leak free installation.
