BELZONA WATERPROOFS CORPORATE HEADQUARTERS

ID: 6188

Application: RPA-Roof Problem Areas

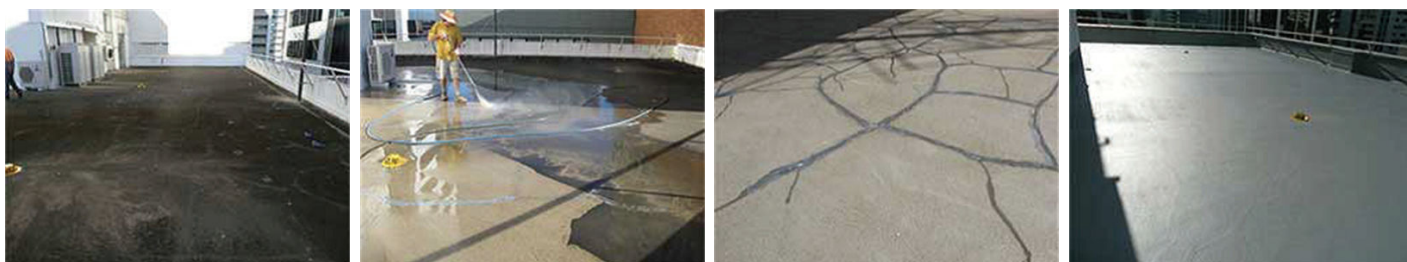
Improper sealing of the roof structure of the high rise building was allowing water to leak into the offices below.

* 1. The existing roof 2. Power washing in progress 3. Cracks exposed and sealed with Belzona 4151 4. The finished application after application of the Belzona 3111 system ,

Application was carried out in accordance with Belzona System Leaflet RPA-1. The roof of the building was cleaned using a high pressure water wash and detergent. Once Cleaned, cracks were filled and sealed using Belzona 4151. The entire roof was then sealed using the fully reinforced Belzona 3111 system to prevent any future water ingress.
