DAMAGED RUBBER LINING RESTORED

ID: 619

Customer Location: Water treatment plant, Egypt
Application Date: October 2001

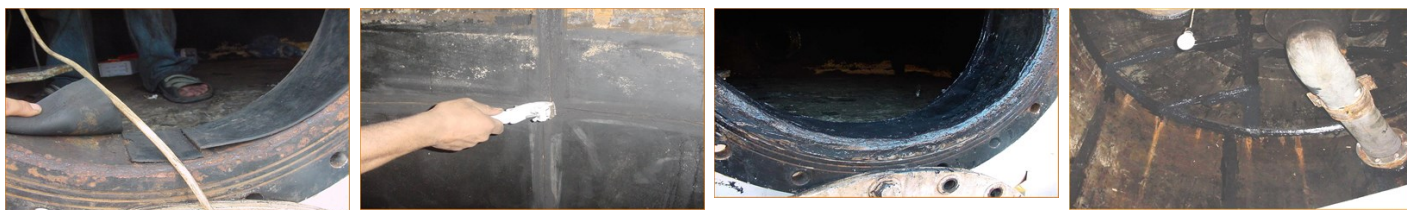
Photograph Descriptions

Peeled-off lining at welding edges causing under lining corrosion due to sea water penetration between the rubber sheets.

- * Peeled-off lining ,
- * Surface preparation of rubber at the welded seams areas ,
- * Problem solved ,
- * Sealed seams ,

Belzona performed easy, onsite repair of the existing lining. No new lining is required and all seams between the rubber sheets were well sealed and protected.
