# BELZONA REPAIRS CONCRETE AFTER BOLLARD REMOVAL

Industry: Buildings & Structures  
Application: FPA-Floor Problem Areas  
Substrate: Concrete  
Products: \* Belzona 4111 (Magma Quartz),

Customer Location: Shopping Centre, Bankstown, Australia  
Application Date: September 2004

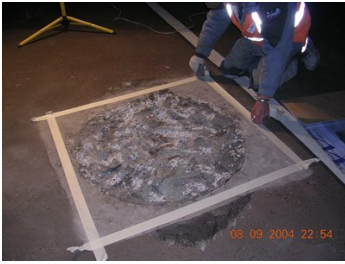
Removal of bollards left rough concrete substrate that was a trip hazard.

- \* 1. Damaged concrete ,
- \* ,
- \* 2. Conditioner applied ,
- \* ,
- \* 3. Mixing Belzona 4111 ,
- \* ,
- \* 4. Applying Belzona 4111 ,

Damaged concrete in 48 areas where bollards were removed
