# BELZONA REPAIRS CAR PARK FLOOR

Customer Location: Shopping centre, Brisbane, Queensland, Australia

Application: FPA-Floor Problem Areas

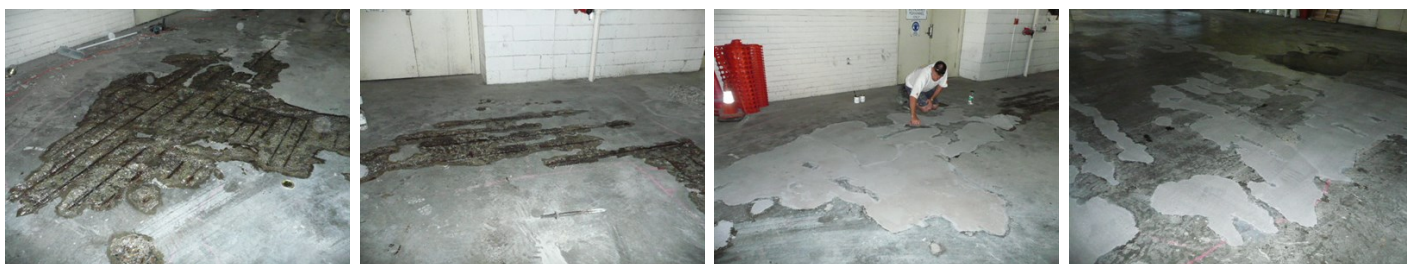
A poorly constructed concrete slab floor had been worn away exposing the reinforcement bars that were becoming a trip hazard

\* 1. The damaged floor showing exposed re-bars 2. More damaged areas 3. Rebuilding with Belzona 4111 in progress 4. Completed application ,

Application was carried out in accordance with Belzona System Leaflet FPA-1. The damaged concrete was removed and the re-bars prepared using wire brushing to remove corrosion from the surface. Once cleaned and vacuumed, the Belzona 4111 system was then applied to the damaged areas and feathered out to provide a smooth surface. Once an area had been completed and cured sufficiently, it was was opened up to the public and the process repeated at the next location.

Belzona 4111 was selected for its high strength, fast application and ability to be applied without the need for extensive surface preparation that kept disruption to the car park to a minimum.
