# KERBS FIXED IN PLACE WITH BELZONA

Customer Location: Shopping centre, Brisbane, Queensland, Australia

Application: FPA-Floor Problem Areas

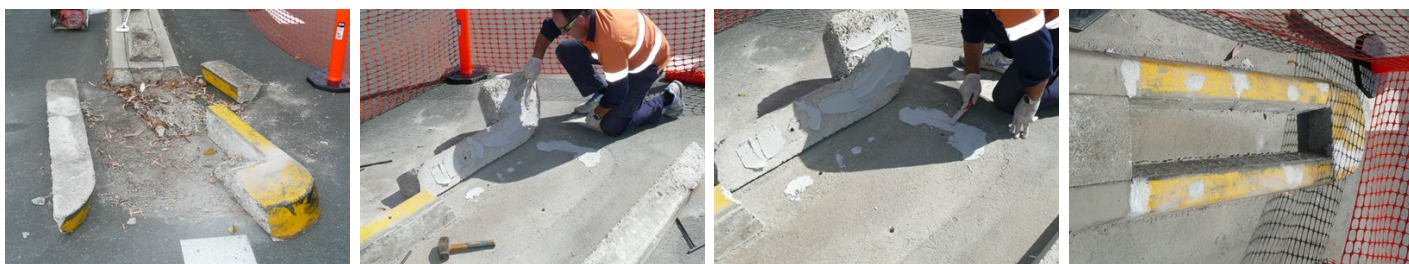
Delivery of some shipping containers carrying tools and equipment for the refurbishment of the centre had caused damage to the demarcation kerbs around the car park.

\* 1. The damaged/missing kerbs 2. Belzona 4111 applied to underside of kerb 3. Belzona 4111 applied to floor prior to refitting the kerb 4. Kerbs permanently back in position ,

Application was carried out in accordance with Belzona System Leaflet FPA-11. The damaged sections of kerb were removed to allow the substrate to be cleaned and prepared before bonding the original kerbs back into place using the Belzona 4111 system.
