# CURING CONCRETE CANCER WITH BELZONA

Customer Location: Apartment Complex, Gold Coast, Australia

Application: WPA-Wall Problem Areas

Concrete balcony at a residential apartment complex

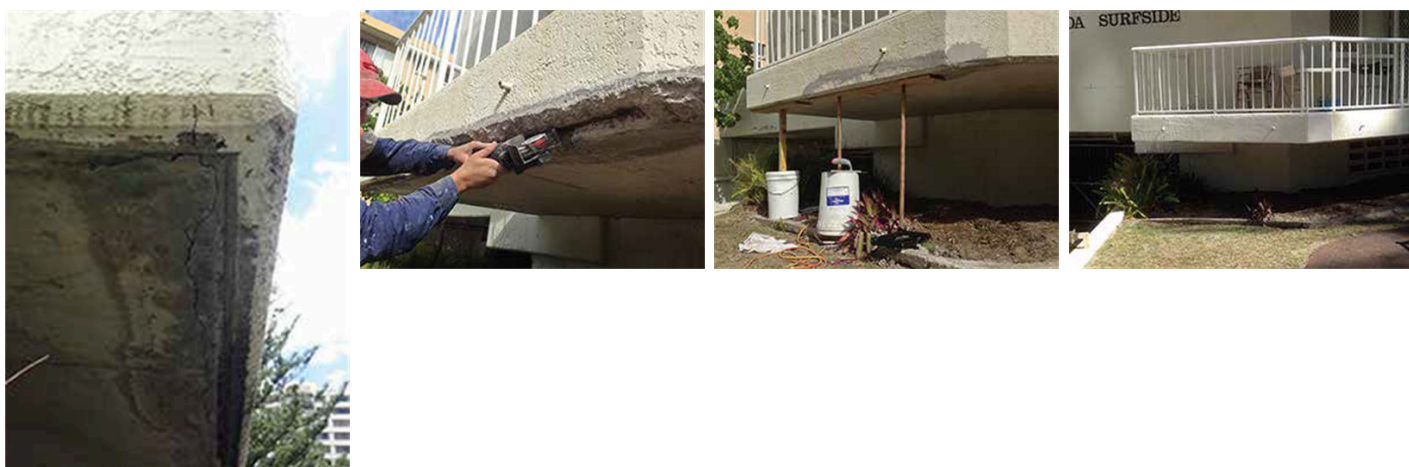
The original concrete was starting to degrade due to a combination of its prominent coastal location and incorrect positioning of the steel reinforcement during original construction. Carbonation had taken place causing corrosion of the reinforcement steel leading to concrete spalling.

\* 1. Close up of the damaged balcony 2. Preparation underway 3. Application completed with temporary shuttering in place 4. The restored balcony ,

Application was carried out in accordance with Belzona System leaflet WPA-4. All areas of damaged concrete were removed back to a sound substrate after which the exposed reinforcement bars were also cleaned back to bright metal. The entire area was then coated with Belzona 4911 (TX Conditioner) before the area was rebuilt with Belzona 4111. Some temporary shuttering to help support the repair whilst it cured was installed. once cured, the shuttering was removed and the area painted to leave a pleasing aesthetic finish.
