BELZONA 4111 BETTER THAN CONCRETE

ID: 621

Industry: Buildings & Structures
Application: FPA-Floor Problem Areas
Substrate: Concrete
Products: * Belzona 4111 (Magma-Quartz) ,
* Belzona 4911 (Magma TX Conditioner) ,

Customer Location: Mass Transit Company, South Texas
Application Date: January 2005

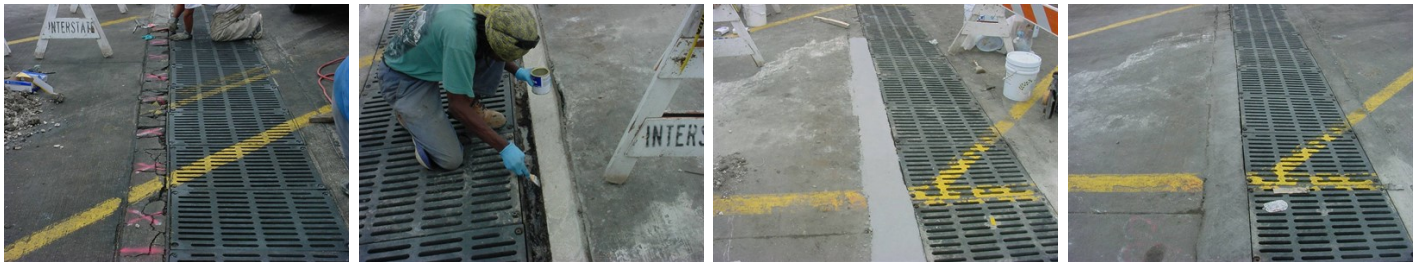
Photograph Descriptions

Heavy buses rolling over drainage channel cracked the concrete curb. Client also wanted to compare Belzona 4111 to concrete as a repair material in side by side comparison.

- * Damaged drainage channel curb ,
- * Area prepared and conditioned with Belzona 4911 ,
- * Belzona 4111 layer in place ,
- * Completed application ,

Application carried out in accordance with Belzona Know-How System Leaflet FPA-1.

After almost one year, Belzona 4111 still in tact while the concrete had not held up in this heavily trafficked bus depot. Repairs carried out quickly with minimal disruption to traffic.
