BELZONA PROTECTS PLATE HEAT EXCHANGER COVERS

ID: 624

Customer Location: *South African Refinery*
Application Date: *Various since 1994*

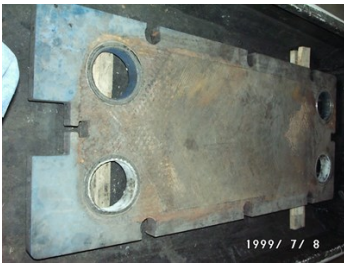
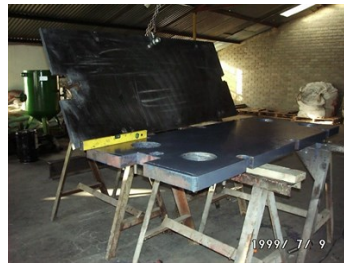
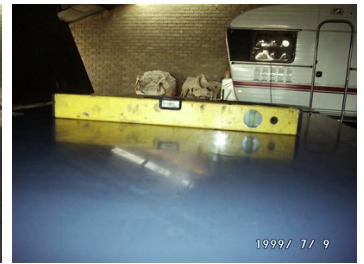
Galvanic and crevice corrosion to the end covers of the heat exchangers was resulting in leaking around the titanium plates and loss of efficiency.

- * Previously corroded cover ,
- * Former clamped into position ,
- * Post application inspection ,
- * Perfectly smooth finish ,

Using a modified version of Belzona Know-How System Leaflet GSS-9, a plate is coated with Belzona® 9411 and used to form a thick layer of Belzona 1341 on the end cover. This procedure provides a perfect finish and excellent seal.
