BELZONA PROTECTS PLATE HEAT EXCHANGER COVERS

ID: 624

Customer Location: *South African Refinery*
Application Date: *Various since 1994*

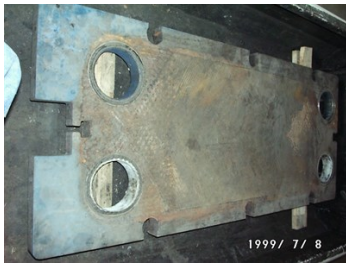
Galvanic and crevice corrosion to the end covers of the heat exchangers was resulting in leaking around the titanium plates and loss of efficiency.

- * Previously corroded cover ,
- * Former clamped into position ,
- * Post application inspection ,
- * Perfectly smooth finish ,

Using a modified version of Belzona Know-How System Leaflet GSS-9, a plate is coated with Belzona® 9411 and used to form a thick layer of Belzona 1341 on the end cover. This procedure provides a perfect finish and excellent seal.
