# BELZONA 5812DW RESTORES POTABLE WATER TANK

Customer Location: Eastern Oklahoma, USA  
Application Date: July 2016

Internal lining and hole patching of a 100,000 gallon potable water tank

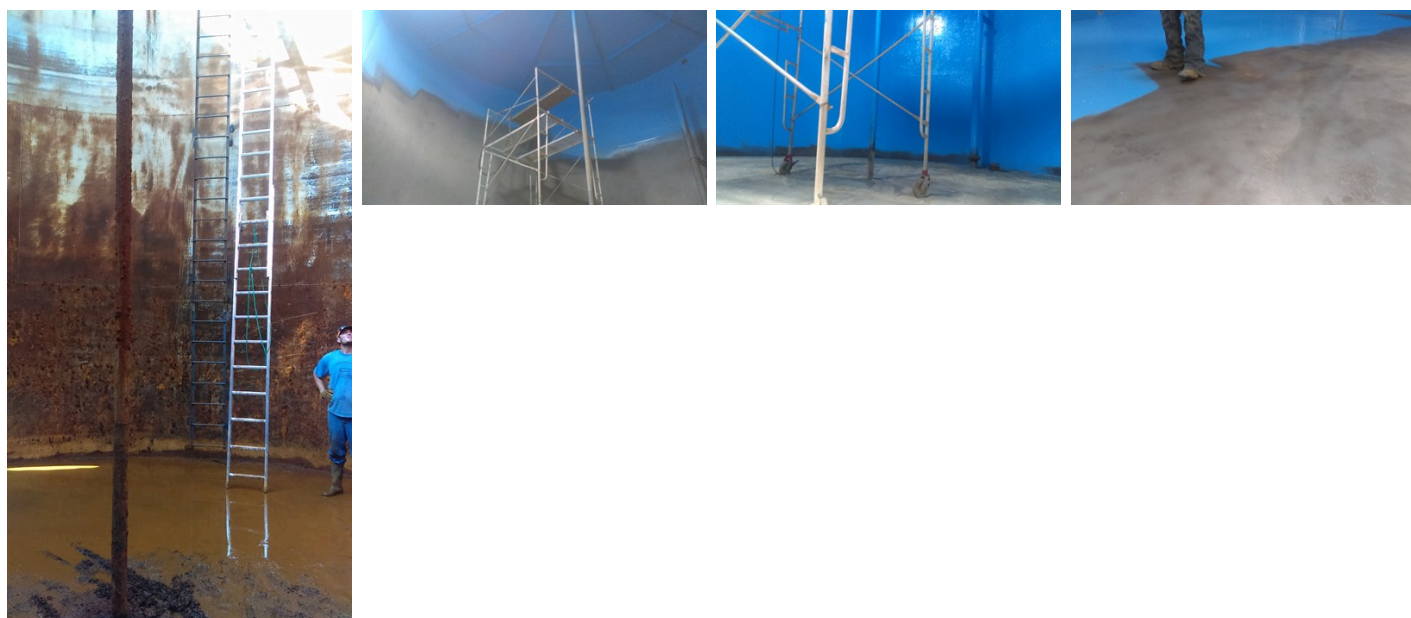
## Photograph Descriptions

This rural water utility's 40-year-old primary storage tank for potable water had corrosion, pitting, sediment build-up, and a few dime-sized holes. Any coating or repair material had to be NSF 61 approved.

- \* 1. Wall of the tank with heavy sediment build-up, surface corrosion and pitting. ,
- \* 2. Surface prepared and application of Belzona 5812DW in progress. ,
- \* 3. Completed application to wall and ceiling with 2 coats of Belzona 5812DW. ,
- \* 4. Coating of the floor completes the restoration. ,

The sediment was removed followed by a thorough surface pressure clean. To ensure effective adhesion the surface was abrasive blasted. Holes were repaired from the outside of the tank using Belzona 1111 and Belzona 9341 in accordance with the Belzona Know-How System Leaflet TCC-1. Belzona 5812DW was applied to the ceiling, floor and inner wall of the tank according to the Belzona 5812DW Instructions for Use document.
