# Belzona Protects Platform Seawater Caisson

Customer Location: North Sea, UK  
Application Date: July 2016

Seawater caisson, an oil platform.

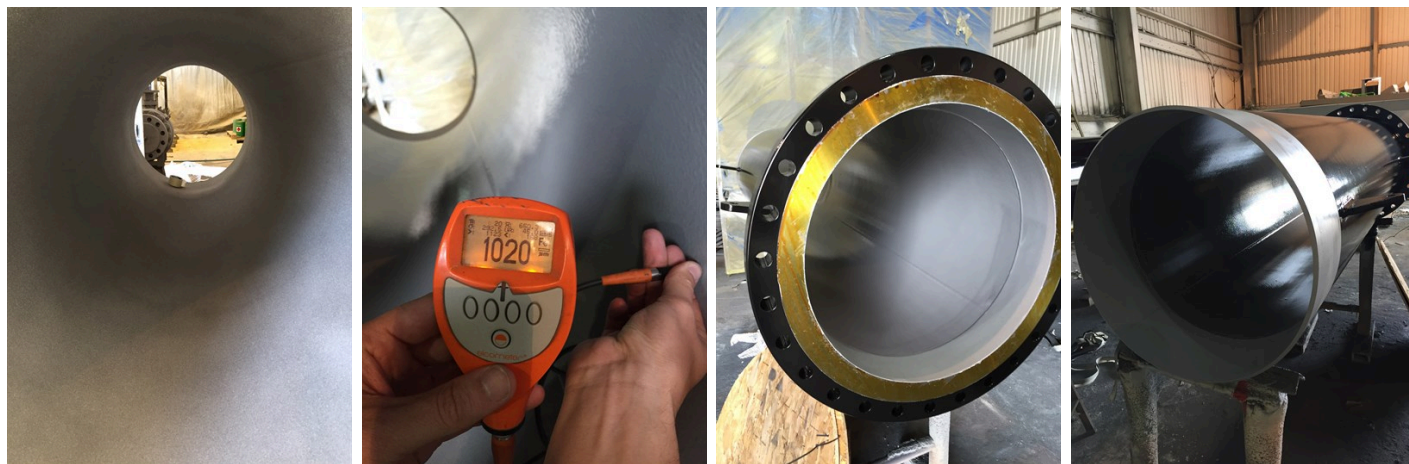
- \* Caisson after grit blasting. ,
- \* Measuring Average dry film thickness (DFT). ,
- \* Completed application. ,
- \* Bottom of caisson section protected. ,

New caisson section was fabricated for replacement and was grit blasted to SA 2.5 before being coated with Belzona 1391S. The application was carried out in accordance with a modified version of Belzona Know-How System Leaflet VPF-2.
