BELZONA CURES DRUG FACTORY FLOOR

Customer Location: Pharmaceutical company, Warsaw, Poland

Application: FPA-Floor Problem Areas

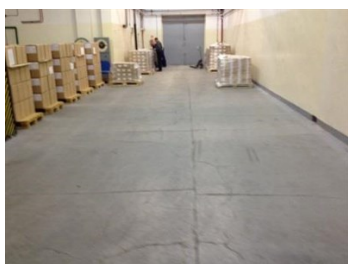
* 1. View of damaged warehouse floor 2. Close up of the cracked concrete 3.and 4. The floor after application of Belzona 5811 ,

Very damaged and cracked concrete floor in the medicines factory.

Application was carried out in accordance with Belzona System Leaflets FPA-1 and FPA-3.

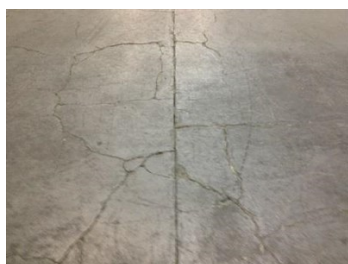
The cracks collect a lot of bacteria and contaminants creating a serious hygiene issue.

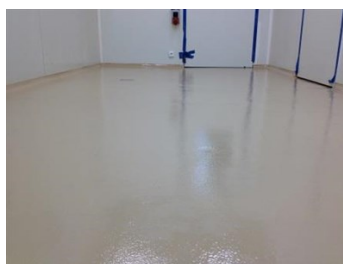
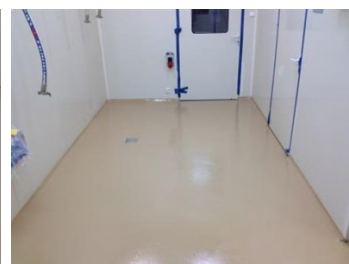
Solvent free Belzona system enabled floor repairs to be carried out with minimal disruption to production in adjoining areas. Belzona repair provided a smooth, easy clean, hygienic surface suitable for pharmaceutical production.
