BELZONA LEVELS TAXI STAND

ID: 6256

Customer Location: Shopping centre, Brisbane, Queensland, Australia

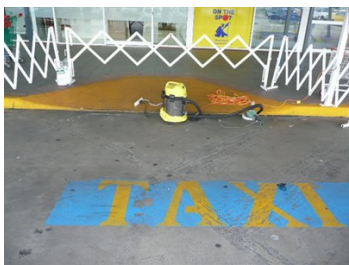
The concrete slab, adjacent to the ramp for the taxi stand, had sunk and created a step that had become a trip hazard. This had also made wheelchair access difficult.

- * 1. The taxi stand ramp ,
- * 2. Close up showing the step between the ramp and road with surface preparation underway ,
- * 3. The finished application ,
- * 4. Three years on and still in perfect condition ,

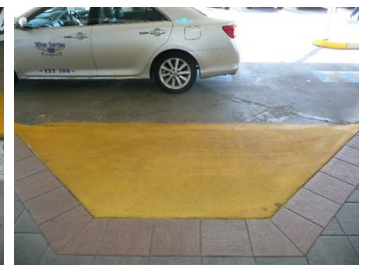
Belzona 4000 series materials are the product of choice for this busy shopping centre because they allow repairs to be carried out quickly and easily with minimum disruption and at the same time provide long term, permanent repairs. Even after 3 years of constant use , the ramp is still performing well with no signs of deterioration or cracking
