BELZONA REBUILDS CRACKED WATER CHANNELS AT OUTDOOR POOL

ID: 6263

Customer Location: Coquitlam, BC

Application Date: April 2015

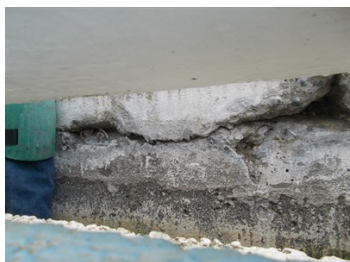
The pool gutter system had developed major cracks in various areas allowing water to escape.

- * Extent of cracks needing rebuilding ,
- * Surface preparation underway using a hand grinder to clean and remove all loose material ,
- * A completed section of repair ,
- * Completed application ,
