# END SUCTION PUMP REPAIRS WITH BELZONA

Industry: *Fluid Flow*  
Application: *PDP-Positive Displacement Pumps*

Customer Location: *Sugar beet plant, Portugal*  
Application Date: *February 2005*

Substrate: *Cast iron*  
Products: *\* Belzona® 1811 (Ceramic Carbide),*  
*\* Belzona® 1812 (Ceramic Carbide FP),*

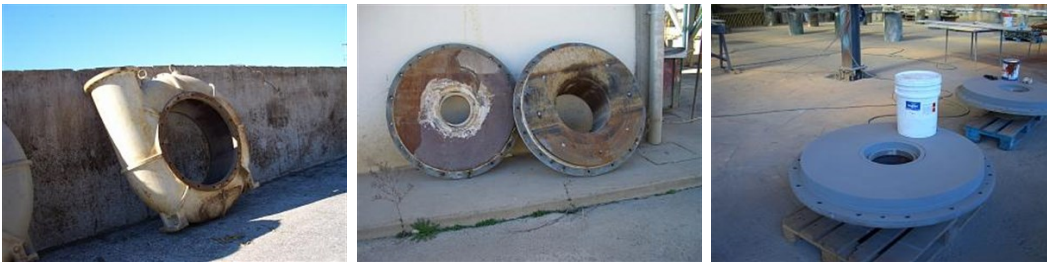
## Photograph Descriptions

*The pumps had suffered severe erosion and significant corrosion caused by solids entrainment.*

- \* Pump housing ,
- \* End covers with erosion clearly evident ,
- \* The components restored to original dimensions ,

Application was carried out in accordance with Belzona Know-How System Leaflet SHM-11.
