# BELZONA SEALS PARAPET WALL

ID: 6276

Customer Location: *Shopping Centre, NSW, Australia*  
Application Date: *July 2004*

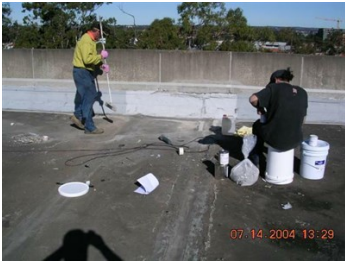
*Ingress of water into the building below caused by failed sealant on the parapet wall joints.*

\* 1. Preparation in progress 2. Surface Conditioner applied 3. completed application ,

Application was carried out in accordance with Belzona System Leaflet RPA-8. A fully reinforced Belzona 3111 system was applied to bridge between roof deck and wall.
