BELZONA RESTORES CORRODED PUMP HOUSING

Application: CEP-Centrifugal Pumps

Horizontal split case centrifugal water distribution pump.

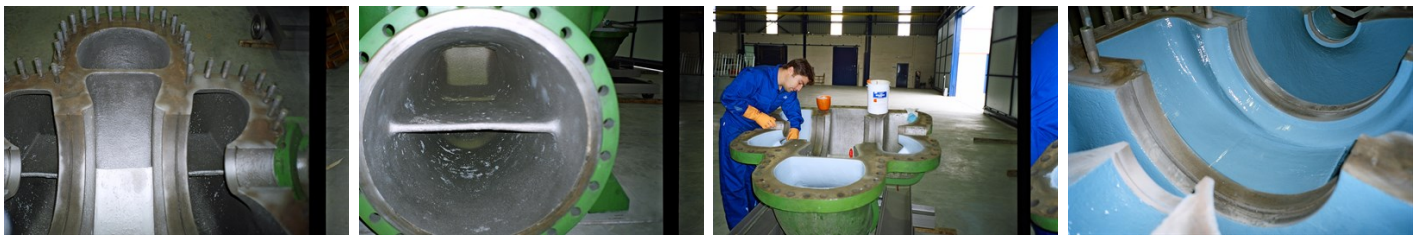
Photograph Descriptions

The pump had extensive corrosion.

- * Corroded pump housing ,
- * Corroded pump outlet ,
- * Application of Belzona® 1341 ,
- * Completed application ,

Application was carried out in accordance with Belzona Know-How System Leaflet CEP-5 & CEP-10.
