# BELZONA REFURBISHED LOADING DOCK STILL GOOD 7 YEARS ON

**Customer Location:** Business complex, Brisbane,  
Queensland, Australia

**Application:** FPA-Floor Problem Areas

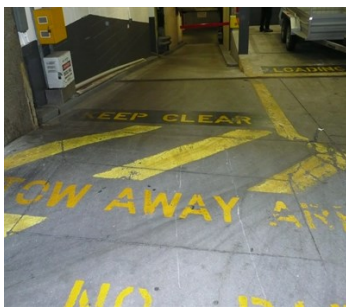
The Loading dock and car park were old and in need of a facelift as all of the original coating had been worn away.

\* 1. The original condition of the floor area 2. Surface preparation in progress 3. The finished application showing the coated floor and reinstated lines, wording and chevrons 4. The floor after 7 years in service ,

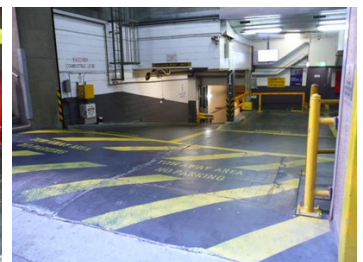
Belzona materials were chosen due to their ease of application, proven longevity and incorporated grip system that provides a safer and more durable finish than conventional floor paints. This decision has proven to be the right one as the floor is still in a serviceable condition 7 years later
