BELZONA REPAIRS AND RESURFACES CRACKS IN CONCRETE SWIMMING POOL TANK

ID: 6284

Customer Location: *Coquitlam, BC*
Application Date: *April 2015*

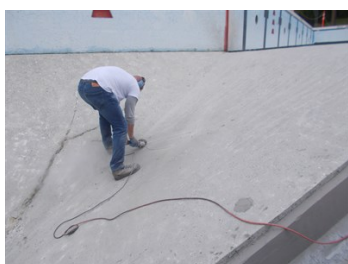
Over a period of many years, the pool tank had developed in the region of 600 lineal feet of cracks. These had been repaired a number of times with limited success.

- * 1. Preparing cracks with a 1/4 inch diamond blade to depth of 1/2 inch. ,
- * 2. General view of various prepared cracks ,
- * 3. Cracks in the pool walls repaired in a similar fashion. ,
- * 4. Completed repairs in the diving tank. A total of more than 600 feet of cracks were rebuilt and resurfaced in this manner. ,

The application was carried out in accordance with Belzona Know-How System Leaflet FPA-1. The surface was prepared by using a 1/4 inch diamond blade. Belzona 4911 was applied and then Belzona 4111 was applied directly on to the conditioned surface with a float.
