BELZONA RESURFACES WATER SUPPLY TROUGH AT OUTDOOR SWIMMING POOL

ID: 6287

Customer Location: *Coquitlam, BC*
Application Date: *April 2015*

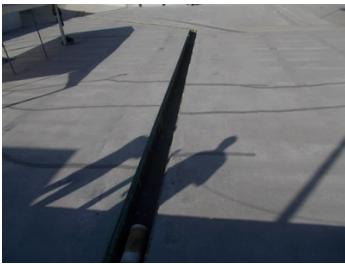
- * 1. View of water supply channel ,
- * 2. View of the eroded surface that needs to be resurfaced ,
- * 3. Resurfacing with Belzona 4111 in progress. ,
- * 4. Completed supply channel ,

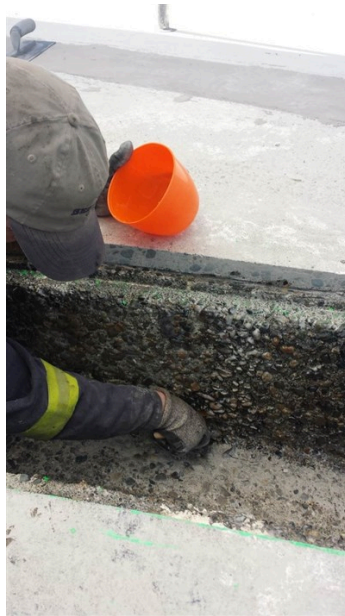
Over period of many years, the pool chemicals had attacked the concrete channel leaving the aggregate exposed. Ultimately loose aggregate would get into the pumps and damage them.
