BELZONA RESURFACES WATER SUPPLY TROUGH AT OUTDOOR SWIMMING POOL

Industry: *Buildings & Structures*
Application: *FPA-Floor Problem Areas*
Substrate: *Concrete*
Products: ** Belzona 4111 (Magma-Quartz),*

Customer Location: *Coquitlam, BC*
Application Date: *April 2015*

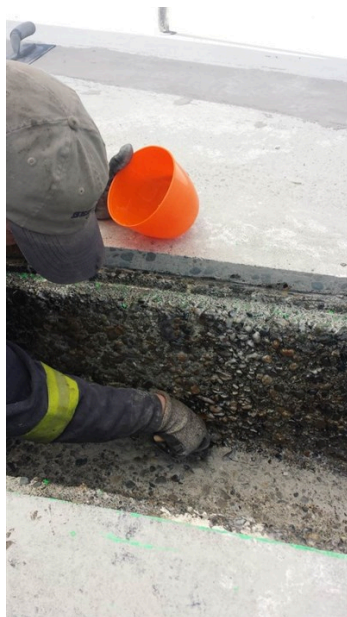
Over period of many years, the pool chemicals had attacked the concrete channel leaving the aggregate exposed. Ultimately loose aggregate would get into the pumps and damage them.

- * 1. View of water supply channel ,
- * 2. View of the eroded surface that needs to be resurfaced ,
- * 3. Resurfacing with Belzona 4111 in progress. ,
- * 4. Completed supply channel ,
