BELZONA SEALS LEAK IN UNDERWATER OBSERVATION WINDOW

ID: 6289

Industry: *Buildings & Structures*
Application: *FPA-Floor Problem Areas*
Substrate: *Stainless Steel/ Butyl Rubber*
Products: ** Belzona 2211 (MP Hi-Build Elastomer) ,*

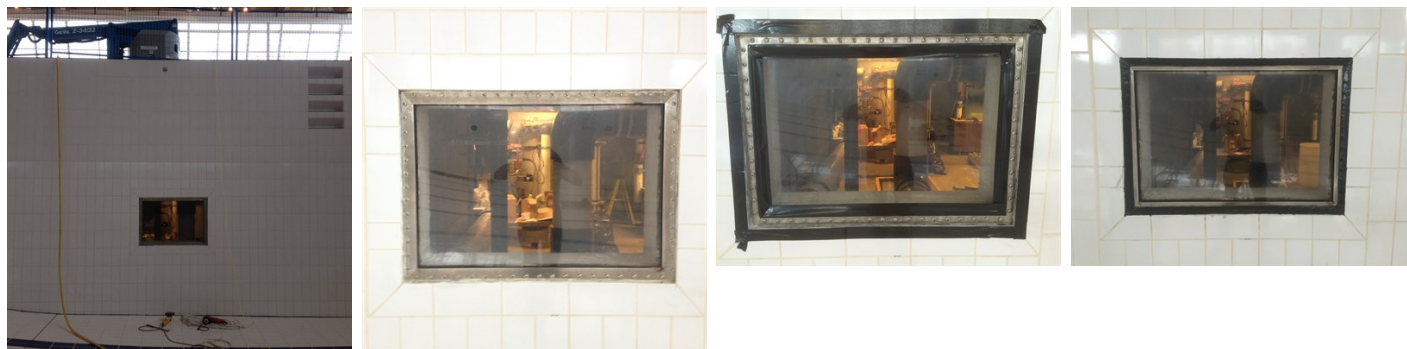
Photograph Descriptions

The underwater observation window had developed a leak.

- * 1. View of observation window ,
- * 2. Metal surface prepared ,
- * 3. Perimeter of the window masked off ,
- * 4. Completed application with all tapes removed ,

The application was carried out in accordance with a modified Belzona Know-How System Leaflet FPA-6. The stainless steel surround was prepared using a grinder to achieve a clean rough profile on the metal surface. After masking off the perimeter, a 1/8" thick rubber tape was used to create a suitable clearance on the inside of the window-sufficient to clear the screw heads.
