BELZONA SEALS HIGH 270° CIRCULAR PARAPET WALL

ID: 6290

Customer Location: Coquitlam, BC
Application Date: August 2015

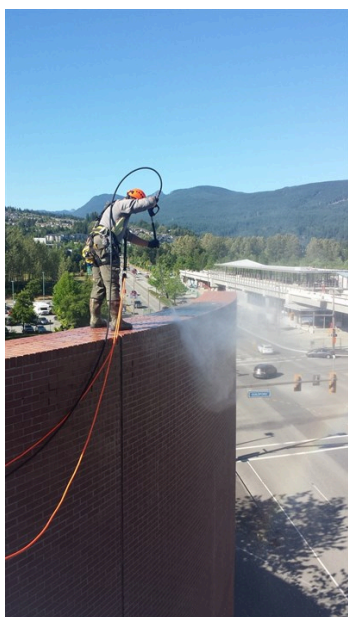
- * 1.View of wall being pressure washed prior to application. It was established at this point that the bricks may have been sealed at some points creating a possible adhesion problem. ,
- * 2.The brick surface being ground to ensure adequate adhesion ,
- * 3.Application of Belzona 3911 ,
- * 4. Application of 1st coat of Belzona 3111 completed. ,
