# BELZONA REPLACES EXPANSION JOINTS IN OLYMPIC SIZED LAP POOL

ID: 6299

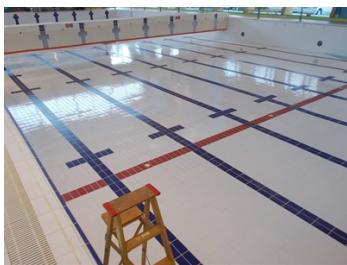
- \* 1. Overall view of the size of the facility ,
- \* 2. Old flexible jointing material being removed. ,
- \* 3. Application of Belzona 2211/2221 ,
- \* 4. Completed application after masking tape has been removed. ,

The application was carried out in accordance with a modified version of Belzona Know-How System Leaflet HEX-13b. The old jointing material was completely removed prior to application. Concrete substrate was roughed and cleaned and then Belzona 2211 and 2221 were injected into the joint before being troweled into place.

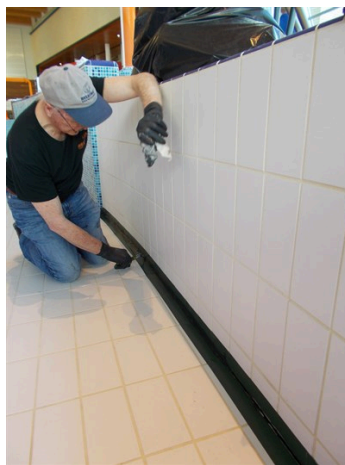
The expansion joints of a pool suffering from chemical attack.
