BELZONA REPLACES EXPANSION JOINTS IN OLYMPIC SIZED LAP POOL

ID: 6299

Customer Location: *Ladysmith, BC*

Application Date: *March 2010*

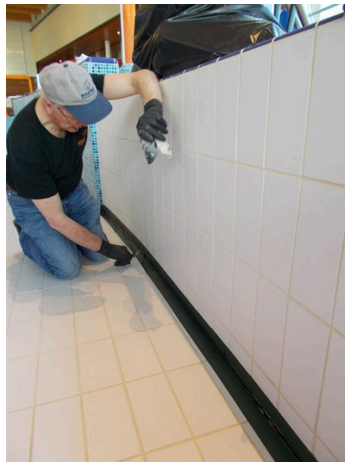
- * 1. Overall view of the size of the facility ,
- * 2. Old flexible jointing material being removed. ,
- * 3. Application of Belzona 2211/2221 ,
- * 4. Completed application after masking tape has been removed. ,

The application was carried out in accordance with a modified version of Belzona Know-How System Leaflet HEX-13b. The old jointing material was completely removed prior to application. Concrete substrate was roughed and cleaned and then Belzona 2211 and 2221 were injected into the joint before being troweled into place.
