# BELZONA 1212 KEEPS RO WATER FLOWING

ID: 6304

Customer Location: Thermal power plant, Warora, India  
Application Date: August 2016

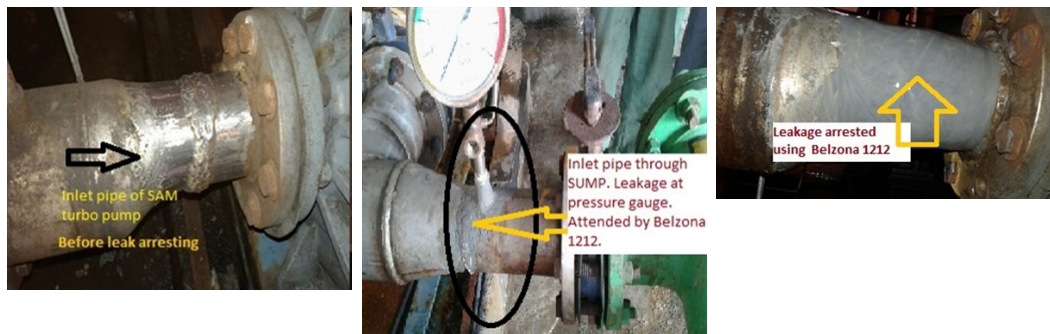
Water leakage at 5-6 kg/cm<sup>2</sup> at 7 numbers of circumferential joints from inlet pipe of SAM turbo pump.

\* 1. SAM Turbo Pump before repair 2. Wetting the surface with Belzona 1212 3. Finished repair ,

Application was carried out in accordance with Belzona System Leaflet VPF-11. Leakages located on-line under operation. Surface preparation with hand grinder to prepare the substrate. Belzona 1212 incorporating two wraps of Belzona 9341 applied with system offline. System allowed to cure for 3 hrs at 30°C before bringing system back online.
