Belzona Reseats Rudder to a Rudder Stock

ID: 6319

Industry: Marine
Application: SOS-Ships and Offshore Structures

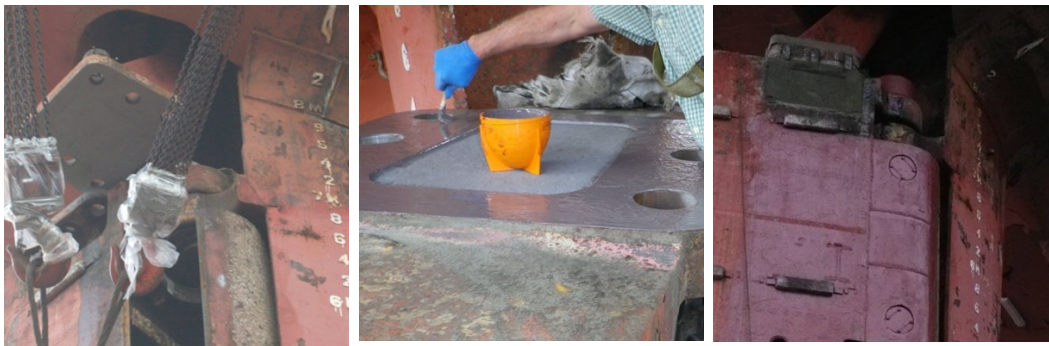
Photograph Descriptions

Corrosion had developed between the two mating surfaces that made it impossible to effectively seal against sea water penetration. The alternate method of repair would be machining both surfaces which would have been impossible under these dry docking conditions.

- * The corroded surface of the rudder after grit blasting. ,
- * The repair area coated with Belzona 1321. ,
- * The completed application. ,

The application was carried out in accordance with a modified version of Belzona Know-How System Leaflet SOS-8. The corroded surface of the rudder was grit blasted to a near white metal finish. While the other surface was cleaned and coated with Belzona 9411. The grit blasted surface was given a full coat of Belzona 1321 and allowed to firm up for approximately 2 hours before it was bolted into position.
