BELZONA REPAIRS HOLES WITH BULKFILL AND MAGMA QUARTZ

ID: 6324

Customer Location: Truck Part Manufacturer, NC, USA
Application Date: June 2016

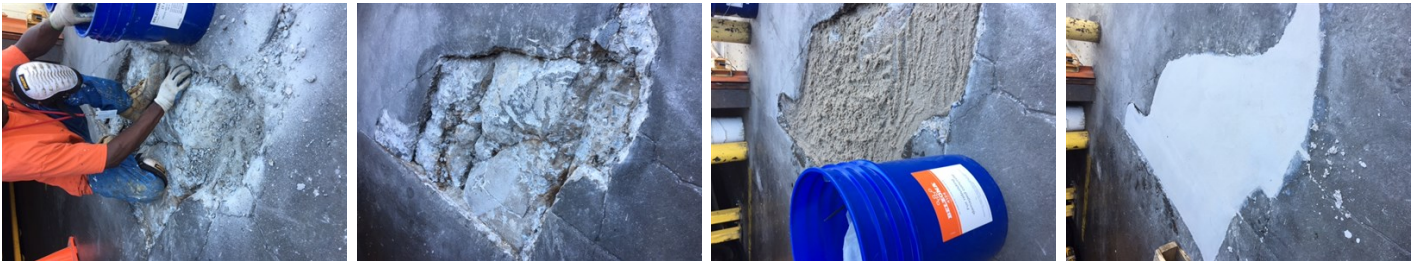
Photograph Descriptions

Due to continuous forklift traffic holes had formed causing an issue in operations.

- * 1. Preparing hole by removing loose material ,
- * 2. After preparation ,
- * 3. Bulkfilling with Belzona 4124 ,
- * 4. Top coated with Belzona 4111 ,

The holes were cleaned out and filled with Belzona 4124. Once the holes were filled, it was top coated with Belzona 4111. FPA-1 System Leaflet was followed.
