# BELZONA REPAIRS HOLES WITH BULKFILL AND MAGMA QUARTZ

**Industry:** Buildings & Structures  
**Application:** FPA-Floor Problem Areas  
**Substrate:** Concrete  
**Products:** \* Belzona 4111 (Magma-Quartz) ,  
\* Belzona 4124 (Bulkfill) ,

**Customer Location:** Truck Part Manufacturer, NC, USA  
**Application Date:** June 2016

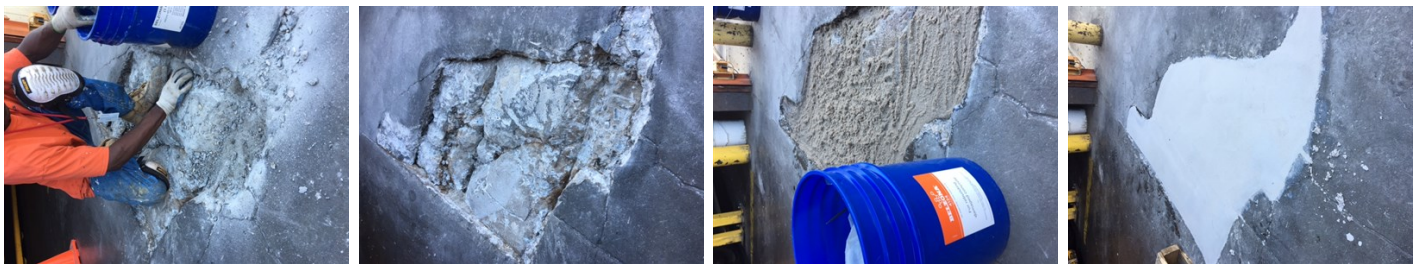
*Due to continuous forklift traffic holes had formed causing an issue in operations.*

- \* 1. Preparing hole by removing loose material ,
- \* 2. After preparation ,
- \* 3. Bulkfilling with Belzona 4124 ,
- \* 4. Top coated with Belzona 4111 ,

The holes were cleaned out and filled with Belzona 4124. Once the holes were filled, it was top coated with Belzona 4111. FPA-1 System Leaflet was followed.
