# BELZONA REBUILDS CONDUIT GAP

**Industry:** General Industry  
**Application:** FPA-Floor Problem Areas  
**Substrate:** Concrete  
**Products:** \* Belzona 4154 (Bulkfill Resin) ,  
\* Belzona 4111 (Magma-Quartz) ,

**Customer Location:** Battery Manufacturing Plant, NC, USA  
**Application Date:** June 2016

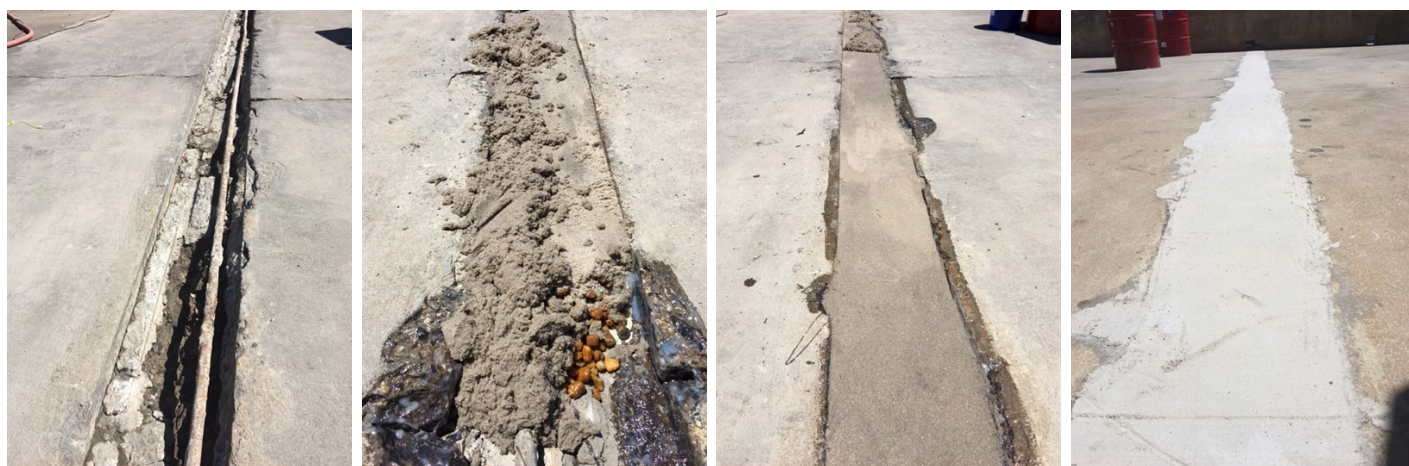
Conduit was buried in concrete. The concrete started failing.

- \* 1. Empty conduit gap. ,
- \* 2. Taking up volume with Belzona 4154 with river rock followed by Belzona 4154 with sand on top. ,
- \* 3. After spreading the Belzona 4154 with sand. ,
- \* 4. Top coated with Belzona 4111. ,

All the concrete was cleaned out and where it was not already rough, grinders were used to roughen the substrate. Belzona 4154 was mixed with clean river rock to bulkfill the conduit gap. Once the conduit gap was filled up, Belzona 4154 was mixed with sand and spread out. The bulkfill was top coated with Belzona 4111 for added strength and blend. The application was carried out in accordance with Belzona Know-How System Leaflet FPA-12.
