GRIPPING BELZONA SOLUTION FOR THE MILLENNIUM BRIDGE

ID: 6326

Customer Location: Local Authority, Gateshead, UK
 Application Date: July 2012

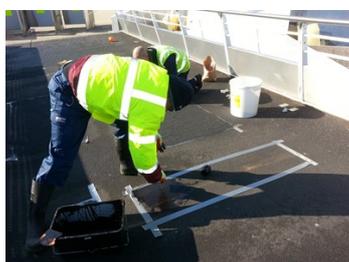
- * 1. View of Millennium Bridge ,
- * 2. Application of Belzona 5811 ,
- * 3. Completed patch repairs ,
- * 4. Application revisited in 2016 ,

The application was carried out in accordance with Belzona Know-How System Leaflet FPA-8. The worn areas were masked off, cleaned and dried prior to application of the Belzona system. Two coats of Belzona 5811 were applied then blinded out with Belzona 9231 Aggregate and tamped down with a piece of timber. Once the product had cured all loose aggregate was removed to reveal the desired non-slip surface.
