GRIPPING BELZONA SOLUTION FOR THE MILLENNIUM BRIDGE

Customer Location: Local Authority, Gateshead, UK
Application Date: July 2012

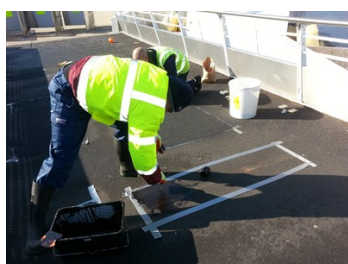
The local council required a number of patch repairs to the bridge due to wear on the original system causing slip hazards especially in the damp winter months.

- * 1. View of Millennium Bridge ,
- * 2. Application of Belzona 5811 ,
- * 3. Completed patch repairs ,
- * 4. Application revisited in 2016 ,

The application was carried out in accordance with Belzona Know-How System Leaflet FPA-8. The worn areas were masked off, cleaned and dried prior to application of the Belzona system. Two coats of Belzona 5811 were applied then blinded out with Belzona 9231 Aggregate and tamped down with a piece of timber. Once the product had cured all loose aggregate was removed to reveal the desired non-slip surface.
