Belzona Coats Submersible Pump for Potable Water

Customer Location: Filtration Plant, Montréal, Québec, Canada

Application: CEP-Centrifugal Pumps

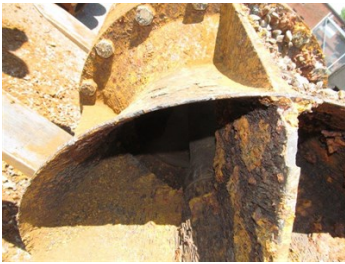
After several years in use this pump needed to be repaired and protected due to erosion/corrosion. Being a filtration plant a product with NSF 61 approval was specified by customer.

Corroded suction bell needed repair

Suction bell rebuilt with Belzona 1111 and overcoat with Belzona 5812DW

Belzona surface preparation respected. 3 mils roughness profile. Aluminium oxide angular abrasive was used for blasting. Belzona system leaflets, CEP-3, 4, 6, was followed.

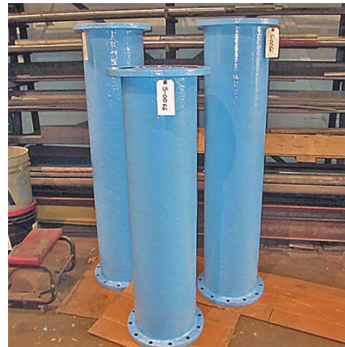
Other pump parts coated inside out with Belzona 5812DW
