BELZONA 7111 ALIGNS NEW INDUSTRIAL EQUIPMENT

ID: 6329

Industry: General Industry
Application: GSS-Gaskets, Seals and Shims
Substrate: Steel base, concrete floor
Products: * Belzona 7111 ,

Customer Location: Manufacturing Plant, FL, USA
Application Date: August 2016

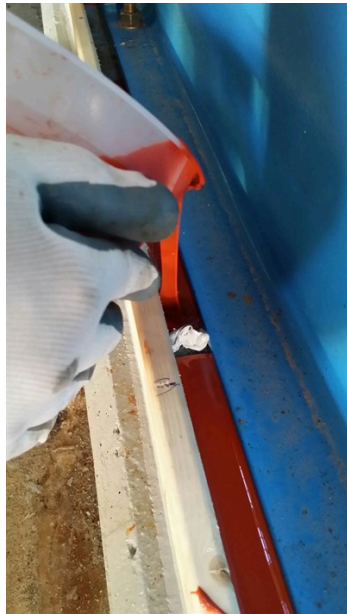
- * 1. View of the gap needed to be filled. ,
- * 2. Temporary wood dam and expansion joint. ,
- * 3. Pouring of first layer. ,
- * 4. After dam removal. ,

New factory expansion needed chocking of three recently installed machinery. Leveling of the equipment was critical as well as preventing water with salt residues from penetrating beneath the bases.
