BELZONA 7111 ALIGNS NEW INDUSTRIAL EQUIPMENT

ID: 6329

Customer Location: Manufacturing Plant, FL, USA
Application Date: August 2016

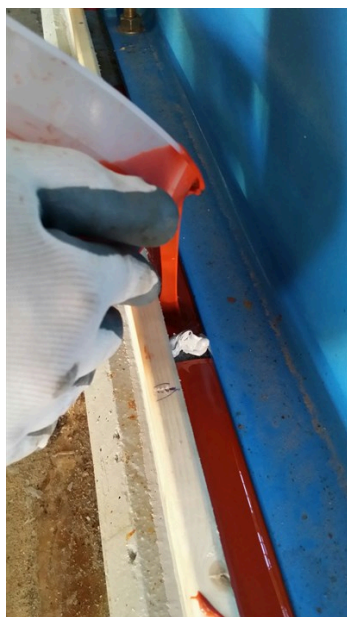
- * 1. View of the gap needed to be filled. ,
- * 2. Temporary wood dam and expansion joint. ,
- * 3. Pouring of first layer. ,
- * 4. After dam removal. ,
