BELZONA PROTECTS HAZARDS DRAIN TANK

ID: 6337

Customer Location: Offshore platform, UK North Sea
Application Date: August 2016

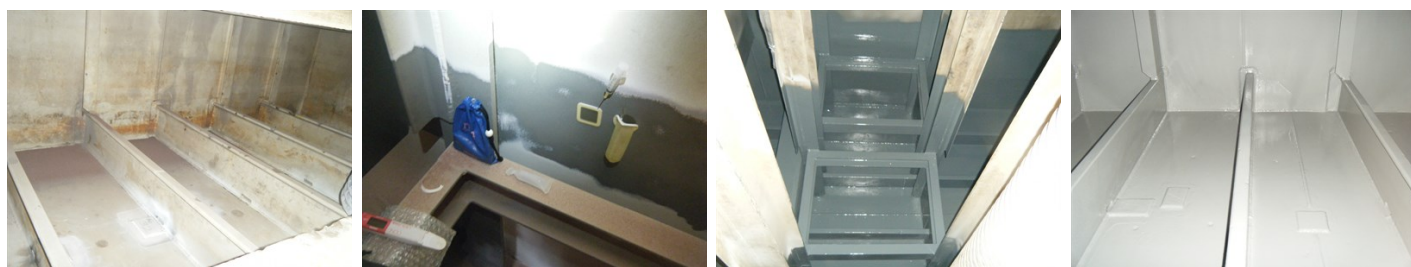
Photograph Descriptions

Once opened and inspected it was decided to replace the lower 1 meter of the existing coating before putting the tank back into service. MIC (microbiologically induced corrosion) was affecting the bottom of the tank and causing local pitting of the steel.

* 1. Original coating 2. Grit blasting underway 3. Inspection of 1st Coat 4. Completed application with 2nd coat applied. ,

A hazards drains tank found to be suffering metal loss when UT inspected.

Application was carried out in accordance with Belzona System Leaflets TCC-3 and TCC-5. after rebuilding deep pits with Belzona paste grade rebuilding product, Belzona 1391S was applied using heated airless spray with Belzona 1391T applied by brush as a stripe coat.
