QUARRY BELT REPAIR

ID: 634

Industry: *Mining & Quarrying*
Application: *SHM-Solids Handling Machinery*

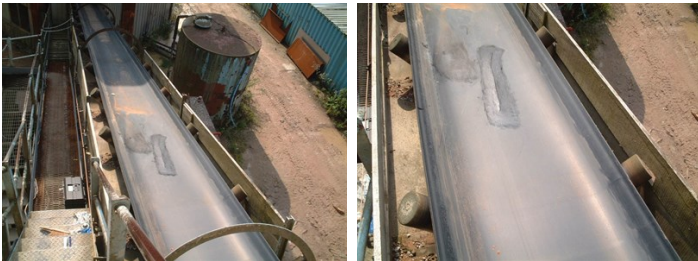
600mm (23inch) tear in the belt

* Large sand belt 600mm gash in the belt ,

Application was carried out in accordance with Belzona Know-How System Leaflet SHM-1.

The belt performed well until the plants closing in 2004.
