BELZONA REPAIRS DAMAGED TRUCK SCALES

ID: 6340

Customer Location: Building materials manufacturer, Croatia
Application Date: August 2016

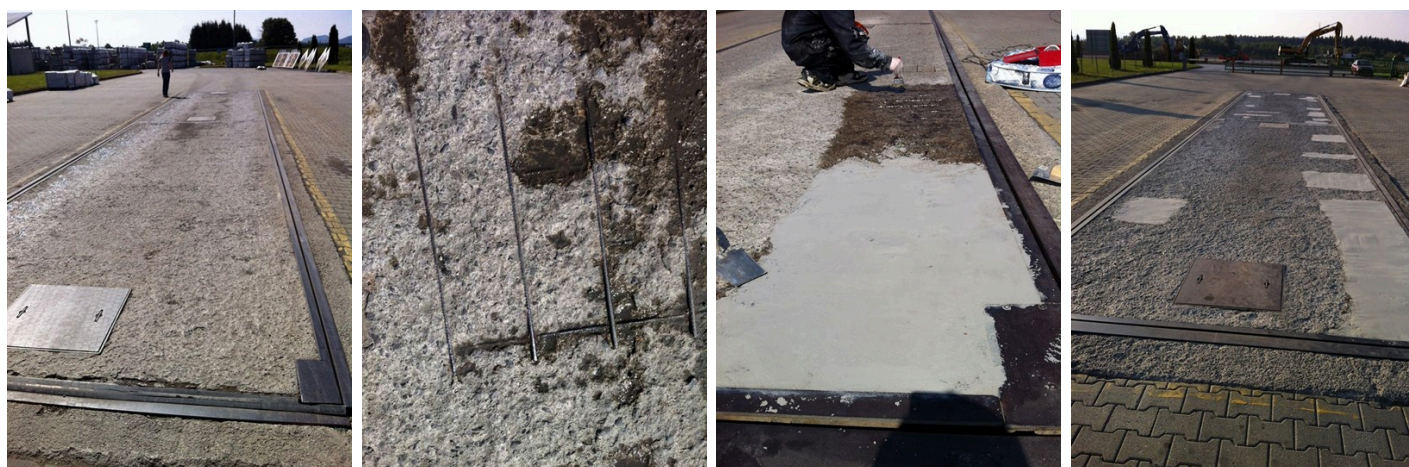
Photograph Descriptions

The concrete surface of the scale suffered severe damage due to the heavy traffic, weather conditions and leaking of fuel, oil etc. Customer needed to address this problem, but due to intensive production it was impossible to put the truck scale out of use for more than a day or two. Belzona offered to repair the most damaged parts of the scale (where the reinforcement bars are exposed), as a first phase, with possibility to resurface the whole scale in the next phase.

* 1. Damaged truck scale - overview 2. Detailed view on one of severely damaged areas 3. Application in progress 4. Completed application ,

The application was carried out in accordance with Belzona Know-How System Leaflet FPA-1.
