Belzona Repair on Concrete Dam

ID: 6343

Industry: Buildings & Structures
Application: WPA-Wall Problem Areas
Substrate: Concrete
Products: * Belzona 4131 (Magma-Screed) ,
* Belzona 4141 (Magma-Build) ,
* Belzona 4911 (Magma TX Conditioner) ,
* ,

Customer Location: Michigan, USA
Application Date: September 2016

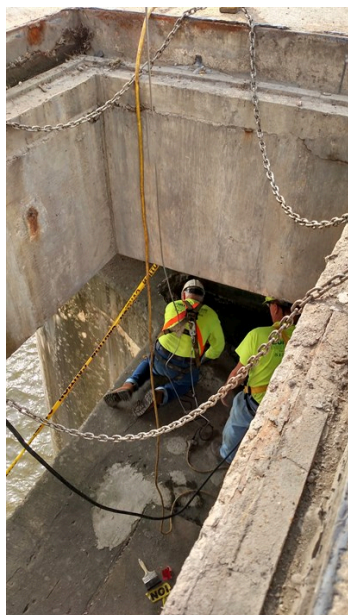
The damaged area is partially submerged and the entire area frequently wet from wave action. The dam has been declared a historic site so repair materials need to closely match the appearance of the original material.

- * 1. Damaged area at waterline ,
- * 2. Work in process. ,
- * 3. Finished repair ,

The face of the 100 yr old concrete hydro dam was damaged at the waterline due to ice and wave action.

A temporary dyke was created around the area needing repair. Compressed air was used to blow the standing water off the

damaged area. The surface was prepped with chisels and a bristle blaster. Dust and loose debris were blown off. The 4911 was applied and the repair was made with 4141 to just below the desired finish level. Finally a coat of 4131 was applied to finish the work .
