BELZONA REPAIRS PUMP FOUNDATIONS

ID: 6350

Customer Location: Petrochemical Co, Romania
Application Date: February 2013

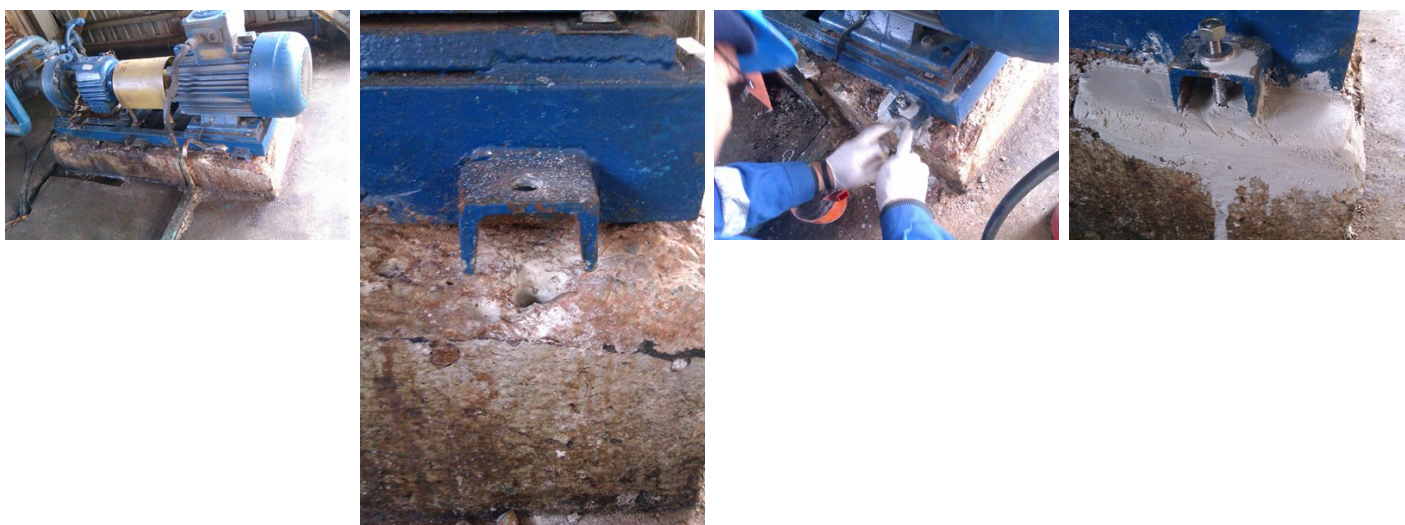
Photograph Descriptions

Due to vibration and contact with petroleum products, the foundation of the pump were showing severe deterioration. Cracks were appearing and the holding down bolts were not secure.

* 1. Pump foundations damaged due to vibration 2. Point of attachment between the pump and pedestal showing signs of deterioration 3. Bolts grouted in place 4. Final repair ,

Deteriorated pump foundations

Application was carried out in accordance with Belzona System Leaflets FPA-1 and FPA-10. The affected area was cleaned by gritblasting and degreased to remove hydrocarbon contamination. The affected areas were then rebuilt, including grouting in new clamping bolts.
